Army Lodging Wellness Recommendation

Fort Richardson - Final Submittal

August 15, 2003

3D/I

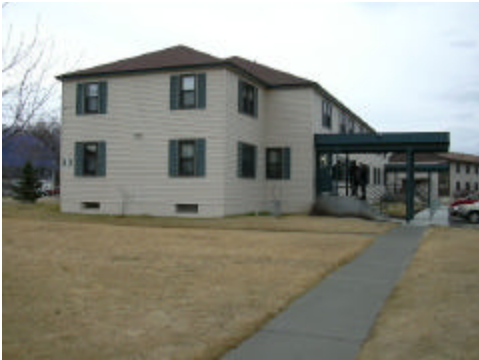
Lodging Building 53

Building 53, constructed in 1949, is comprised of 15 rooms. Although this facility was renovated within the last 5 years, it does not meet Lodging standards and cannot be reconfigured without significant reconstruction. The cost to make improvements and bring this building up to meet Army Lodging standards will exceed the 50% replacement cost.

Our recommendation is to remove building 53 from the Lodging inventory, allowing the installation to determine an alternate use for the facility. This facility will be removed from the Fort Richardson Wellness Solution and Lodging master plan.

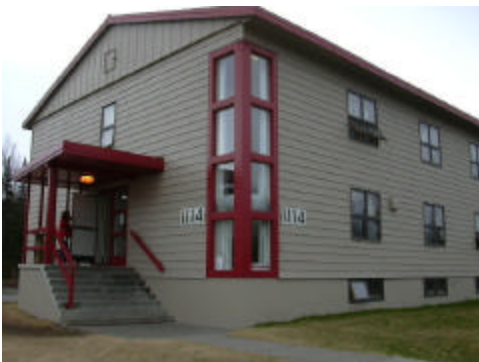
Lodging Buildings 55, 57, 58, 1113, and 1114

The building type depicted by these buildings was repeated throughout the installation. Building 55, built in 1951, has 18 rooms. Building 57, built in 1952, has 12 rooms. Building 58, built in 1952, has 11 rooms. Buildings 1113 and 1114, built in 1954, have 18 rooms. The type of room only varies with regards to the quantity standard rooms it possesses. For instance, a family suite comprised of three bedrooms and one sitting room is actually two standard rooms with a shared bath connected through a doorway. These buildings are operational but do not meet Lodging standards and cannot be reconfigured without significant reconstruction. The cost to make improvements and bring these facilities up to meet Army Lodging standards will exceed the 50% replacement cost.

Our recommendation is to remove these buildings from the Lodging inventory, allowing the installation to determine an alternate use for the facilities. These facilities will be removed from the Fort Richardson Wellness Solution and Lodging master plan.

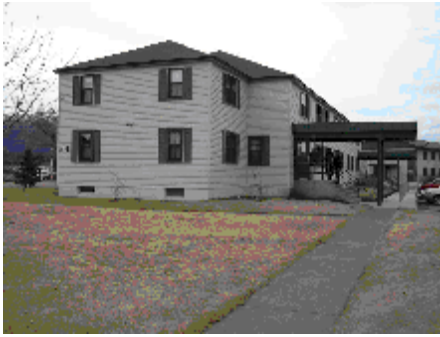
*Building 53
Fourth Street*

Because the Renovation to Replacement Cost Ratio is greater than 50%, renovation of Building 53 is not recommended.

- Analysis: The exterior walls are metal lap siding over 1x6 diagonal sheathing. The siding is in fair condition, but the sheathing does not supply proper shear resistance in this earthquake prone area.
- Recommendation: Replace the siding and sheathing.

- Analysis: The copper piping system is original and is showing signs of failure.
- Recommendation: Replace the domestic water system.

- Analysis: Heating is provided by new gas-fired boilers. The heating piping is original and is damaged. The heating control valves are failing and unable to control temperature in rooms. The building does not have a cooling system.
- Recommendation: Replace the heating piping and control valves.

- Analysis: Panelboards, receptacles, and wires are beyond their expected useful life.
- Recommendation: Upgrade the electrical system with new panels and branch circuits.

- Analysis: The fire alarm system uses a dial up connection to contact the fire department and is not compatible with standard alarm system used at Fort Richardson.
- Recommendation: The fire alarm system needs to be upgraded to meet current code requirements.

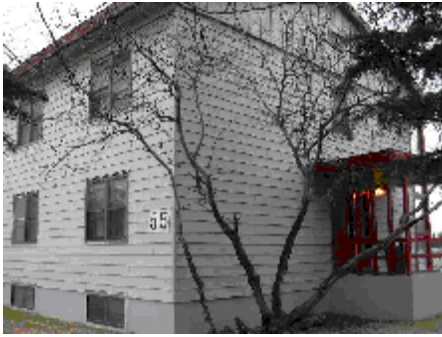
*Building 55
Chilkoot St.*

Because the Renovation to Replacement Cost Ratio is greater than 50%, renovation of Building 55 is not recommended.

- Analysis: The windows are aluminum framed, insulated units in fair condition
- Recommendation: Replace the windows.
